RAILROAD COMMISSION OF TEXAS SURFACE MINING AND RECLAMATION DIVISION

URANIUM EXPLORATION INSPECTION REPORT

Mine Name: Weesatch Project Permit Number: 123
 Permittee: Uranium Energy Corporation (UEC) County: Goliad
 Industry Representative(s) Present: Mike O'Leary
 Inspector: Murphy Hawkins, Michael Gay, Jon Brandt, Dean Poth Date of Inspection: March 7-9, 2007

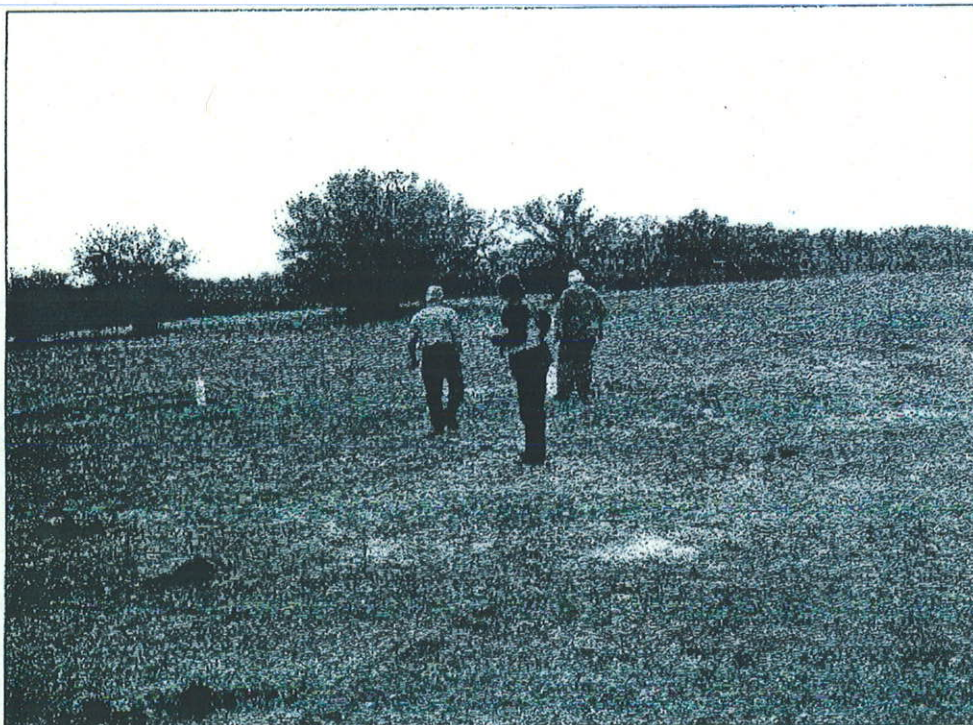
Goliad County Commissioner Jim Krenck, Mr. Art Dohmann, Ms. Margret Rutherford and Dr. H. C. Clark, representing the Goliad County group, were also present on March 7, 2007. At the groups' request, we met them at the property of Mr. Elder Abrameit where they discussed the site conditions that prompted their complaint (see photograph 1).

Photo 1: Abrameit property with members of Goliad County group

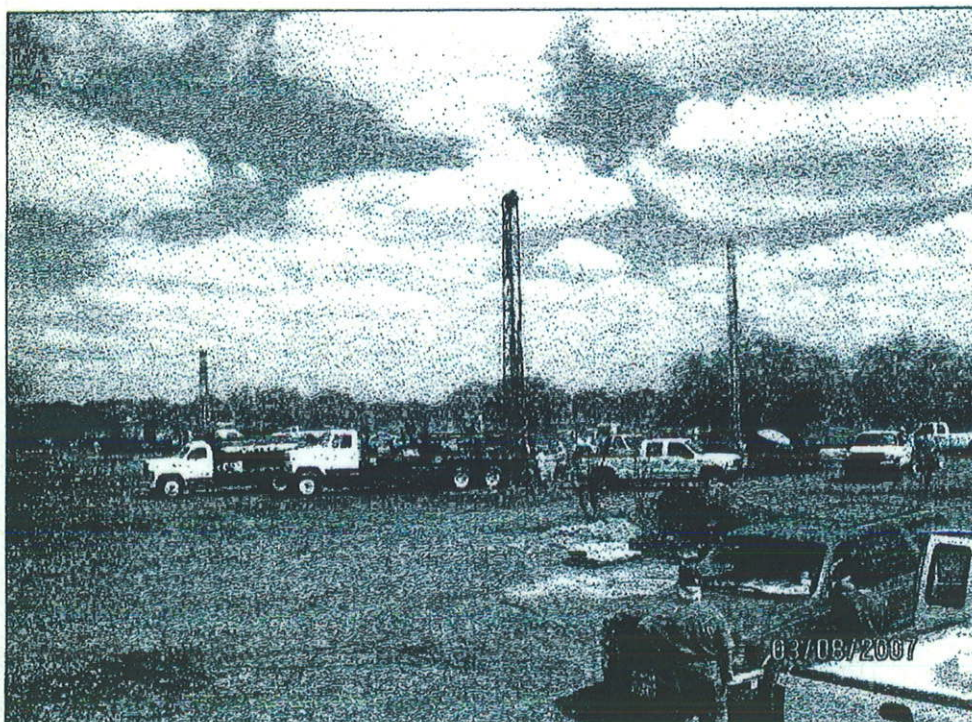
Photo 2: Three of the Four Drill Rigs Active During the Inspection
